Manhole Inspection Summary

Manhole # S27I__022MH

Location Address: **868 Parkins St**

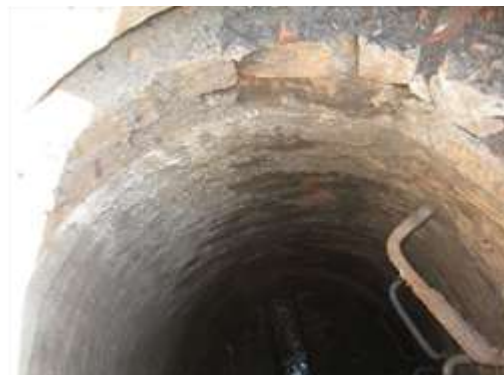
Defect 4

Infiltration: ☐ None ☒ **Joint** ☐ Cracks ☐ Mortar ☐ Roots ☐ Wall

infiltration joint chimney-frame & corbel

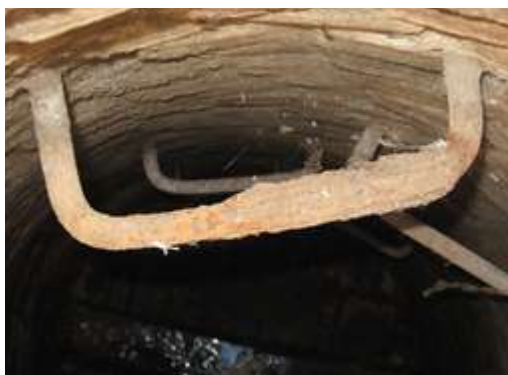
Defect 3

Count: **6** Missing: **0** ☒ **Corroded**

corroded rung

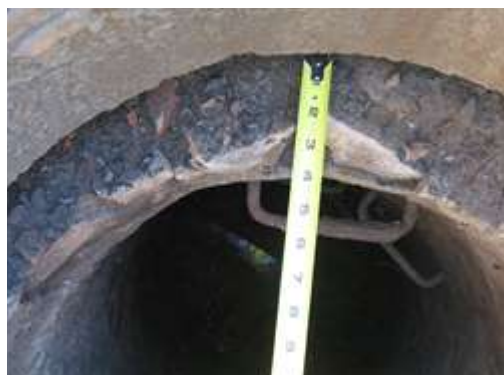
Defect 2

Offset: **2.5** (in.)

2.5" frame offset

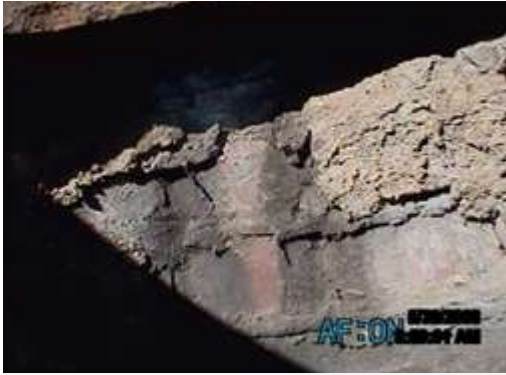
Defect 5

Condition: ☐ Sound ☐ Cracked ☒ **Leaks**

infiltration frame-chimney joint

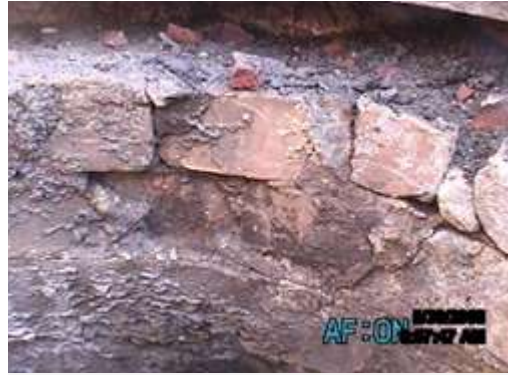
Defect 1

Condition: ☐ Sound ☒ **Cracked** ☐ Root Intrusion ☒ **Loose Brick** ☐ Deteriorated

Infiltration: ☐ None ☒ **Joint** ☒ **Cracks** ☒ **Mortar** ☐ Roots ☐ Wall

missing mortar and bricks, infiltration from chimney-frame joint as well as Id-frame connect..cracked bricks
